Bay Window Caboose Rebuild

The plan presented in this document is to refurbish the NW Bay window caboose into a themed luxury railcar for customer rental (revenue generation) with a construction period of a minimum of one year or to be stretched over time based upon funding available.

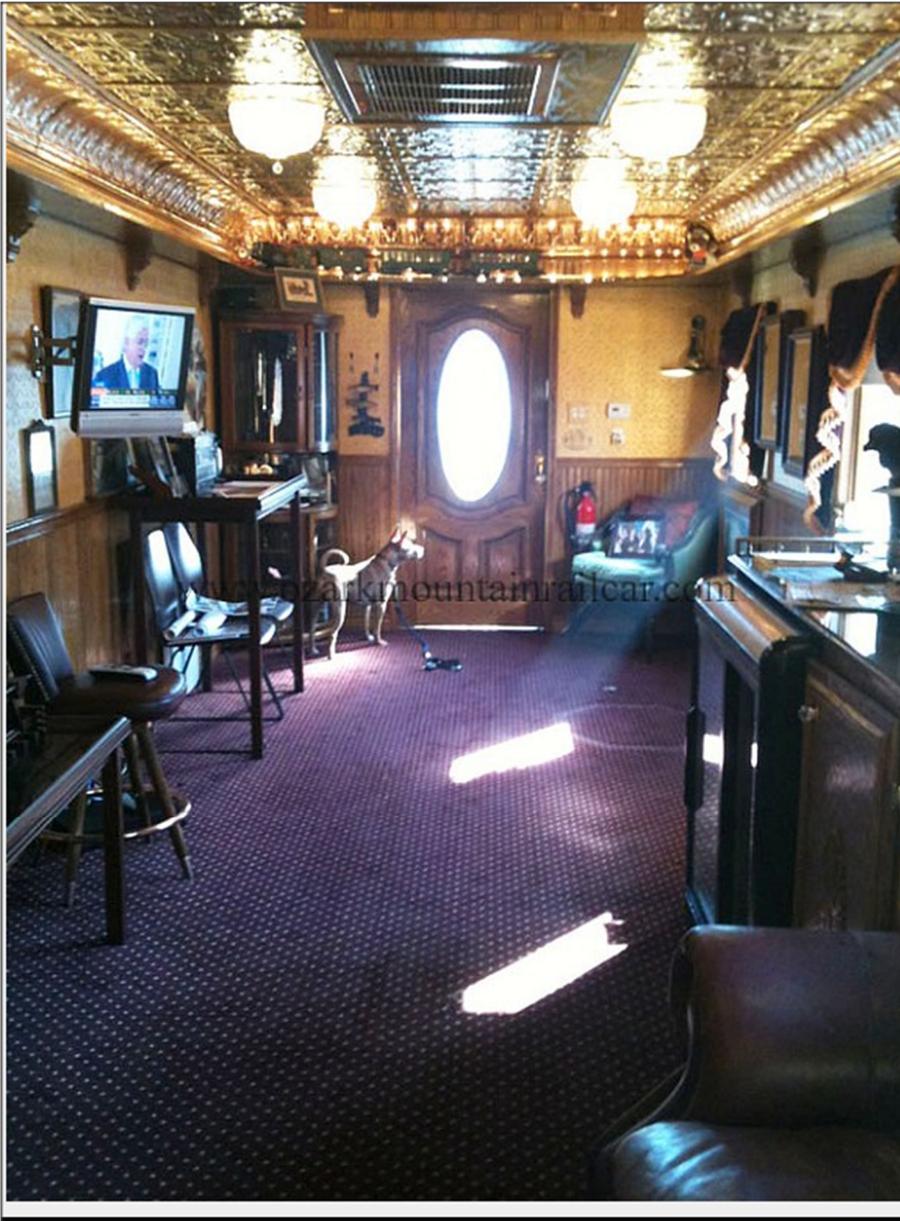
Note the door and the coves. The chandeliers appear to be “crystal” and ceiling mounted.

Since the NHV was chartered in 1906, a glamorous - if not gaudy era - is the look we intend to capture. Though a Pullman was used, a good example of this look is from the TV series "*Wild, Wild West*", where a specially outfitted Pullman was themed for the late 1880s. (A Pullman parlor car - circa 1906 - picture is attached.)

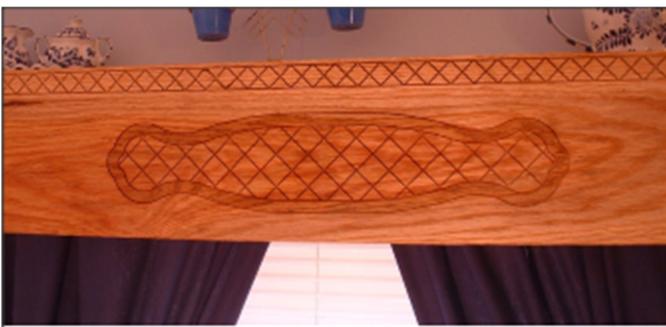
Tiffany style Cornice.

The caboose has a very low ceiling, which if left as is would be claustrophobic for riders. We have about 12" above the current ceiling where we can install a slightly "arched" ceiling. The look here would be to have ornate bolsters along the wall and ceiling (sample picture attached). This would be the best place for wiring and any ductwork.

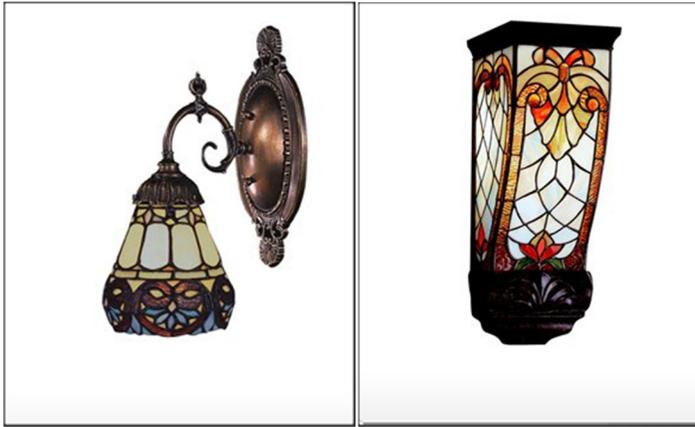
Tiffany stained glass sconces examples. The rectangular narrow style shown may be the best selection for us depending upon the seating, the window placement and the caboose structure itself.

Sconces mounted to the wall were common sources of lighting, especially in buildings. The Tiffany style was the most common at that time. Lighting would be 4-8 Tiffany sconces – depending upon type, window and seat locations and one central Tiffany chandelier hanging over the medallion. (Pictures of typical sconces and ceiling lights are attached.)

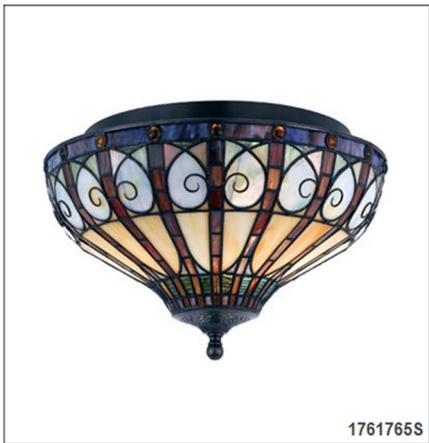
Tiffany stained glass ceiling light. Crystal styles also available but will “tinkle” when in motion.

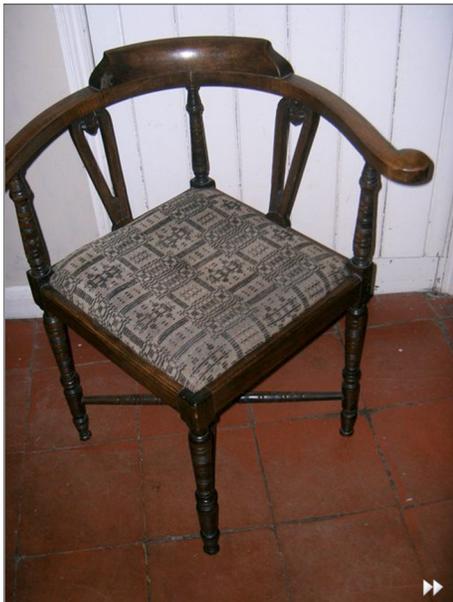
Pictured above is an Edwardian corner chair (1901-1910), with a drop in cushion design (~\$120). Other designs are available and we may want to mix and match. Simpler, more rectangular designs can be replicated by us with time.

Corner chairs, and their close cousins, parlor chairs, have a long history back hundreds of years because of their versatility and size and were common through the mid-1900s. The advantage to us is that a rider can sit in them comfortably and either facing a partner seat or facing across the aisle to create a booth atmosphere. (Note: We may be able to build corner chairs; time and help available.) Corner chairs are also typically small and open – a characteristic we will need for the car.

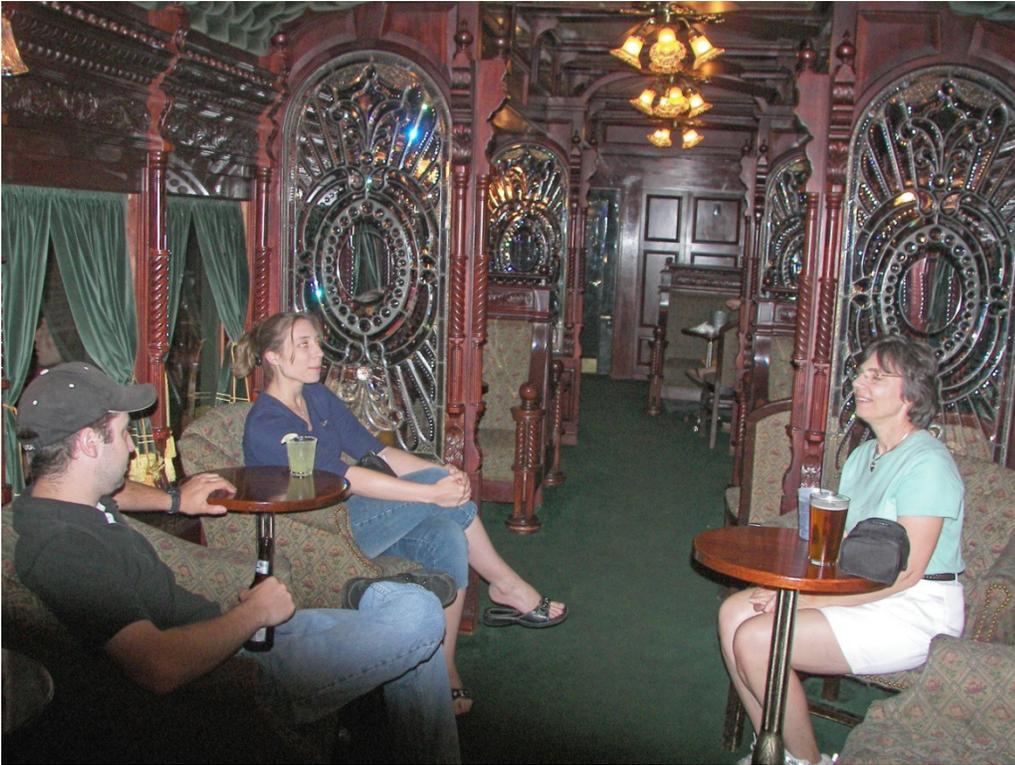
Note the ornate partitions between seating areas. The end door is a 6 panel oak door.

- Between the chair groupings would be narrow partitions that would provide the air of privacy for couples, but would also accommodate larger groups. These narrow partitions would either use stained or beveled glass for the upper part. (Sample picture attached.)

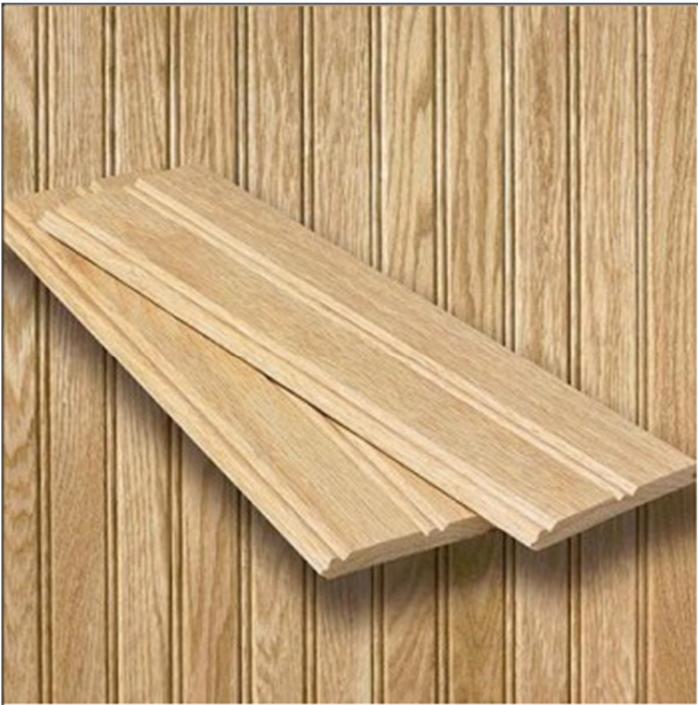
Unstained Oak bead board. We can panel the entire wall or use it as wainscoting then using period wall paper above it.

The walls would be a rich brown oak bead board wainscoting. Above the wainscoting and around the windows will be period wallpapered walls. Above the windows will be decorative carved relief cornices. The windows would have red/gold curtains with lots of fringe. We would use decorative trim wherever required: corners, floor and crown molding.
